THE ANALYSIS OF THE DEFORMED WALL AT DK AREA, AT MOHEN JO DARO

Abstract: The wall of the main street of DK G Area, Mohenjo Daro partially deformed, due to the torque effects this is studied here on a lateral cross wall in the chief house. Furthermore, the resulting behaviour of the bucking wall demonstrates the significant load-bearing capacity of the structure under service conditions and its high sensitivity to imposed changes of the geometry. Although the tensile stresses exceeded the flexural strength at the vertices and the length of the wall, hence both the geometry and condition of this area are critical for the safety of the wall. The results of this study can improve the assessment and thus help in the preservation of many important walls, in the DK Area.

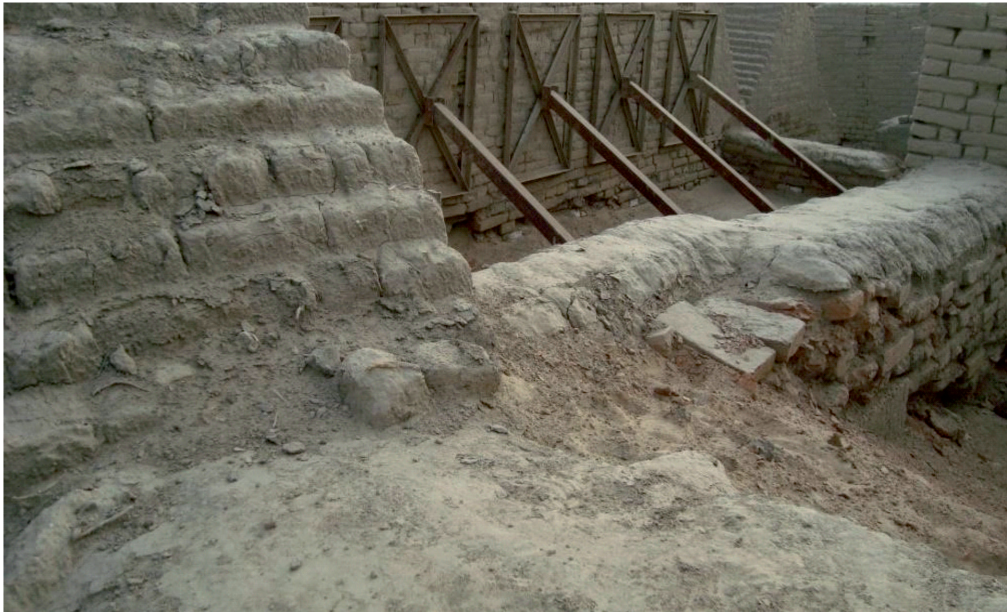
Figure 1: The exo skeletal support (30 March, J.Shaikh 2012)

The timber and iron, I sectioned trusses installed at the chief house, (Fig. 1) prevents the buckling at one side only. Though this intervention compromised

the structural scheme of the building as, Fig. 1, causing an excessive increase of the thrusts on the lateral wall from the external side, which were previously balanced by a system of columns and roof buttresses (original 5000 years ago). In addition, the primary design was constantly transmitting loads and balancing it, hence the weight of the upper structure is usually transmitted through the lateral wall upon the pier with an offset. Today this isolated wall is not behaving similarly, but the entire load is being transmitted to the lower end of this wall, which has to fit in the narrow area of the street. The combination of these forces with the thrust of the continuity resulted in the progressive instability of the lateral wall and the formation of minor and major cracks, at the relatively weak area of the wall.

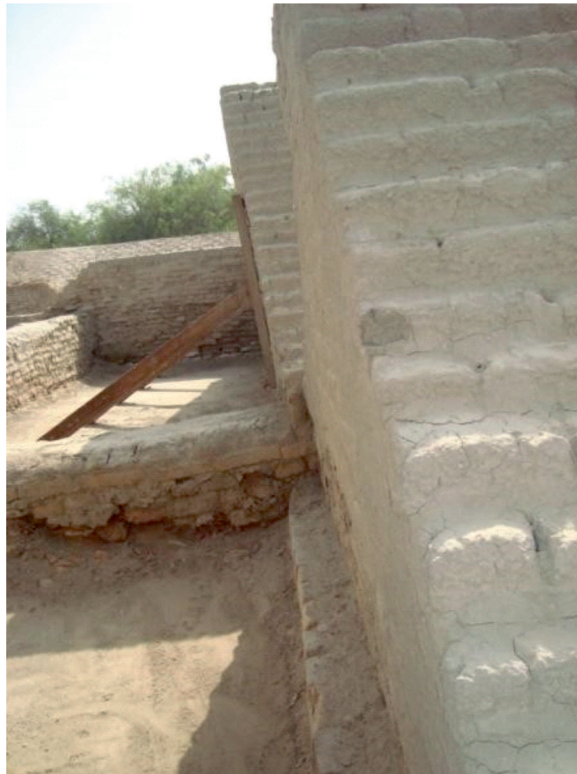
Figure 3: the view of the deformation

Depending on the types and signs of ground surface movement it makes different impact on buildings being determined (Fig. 3). At horizontal tensile deformations inclined cracks in external walls are generated which are

symmetrical relative to the centre of the wall. Vertical bending and vertical shear cracks are typical of curvature of convexity, the bending cracks being typical of flexible walls which lengths exceed their heights more than thrice. Shear cracks are always generated, being more typical of two-storey and higher walls than bending crack. Under horizontal compressive deformations and curvature of concavity inclined and horizontal cracks are generated in the walls located symmetrically relative to the centre of the plan.

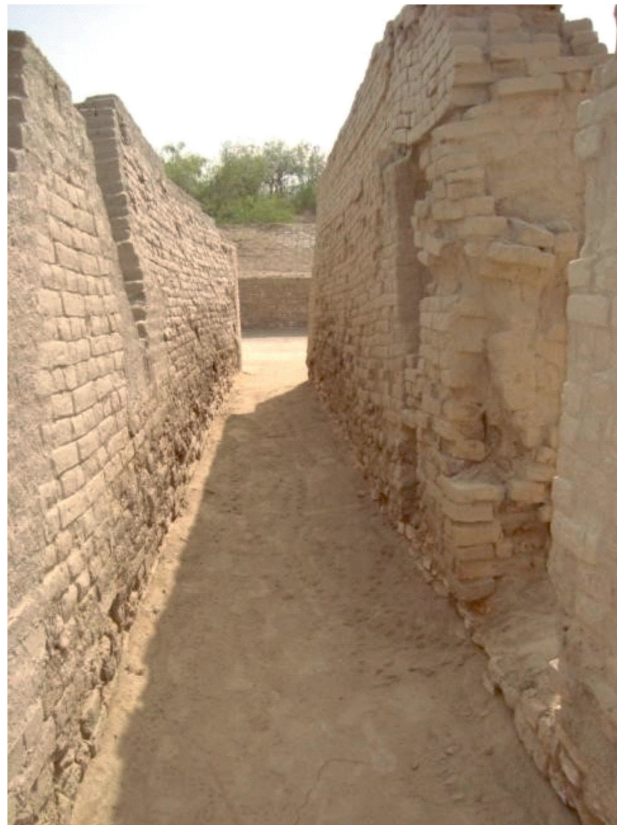
Figure 6: the deformation is seen in the perspective from the outer side
